# PROTECTAHOME LTD STRUCTURAL SOLUTIONS

Case Study 067:

## CINTEC ANCHORS: ALMS HOUSES, WANTAGE

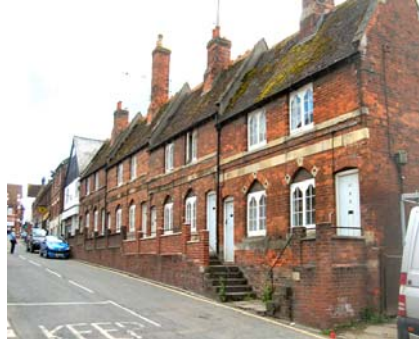
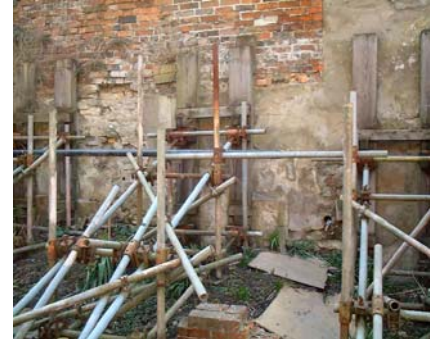
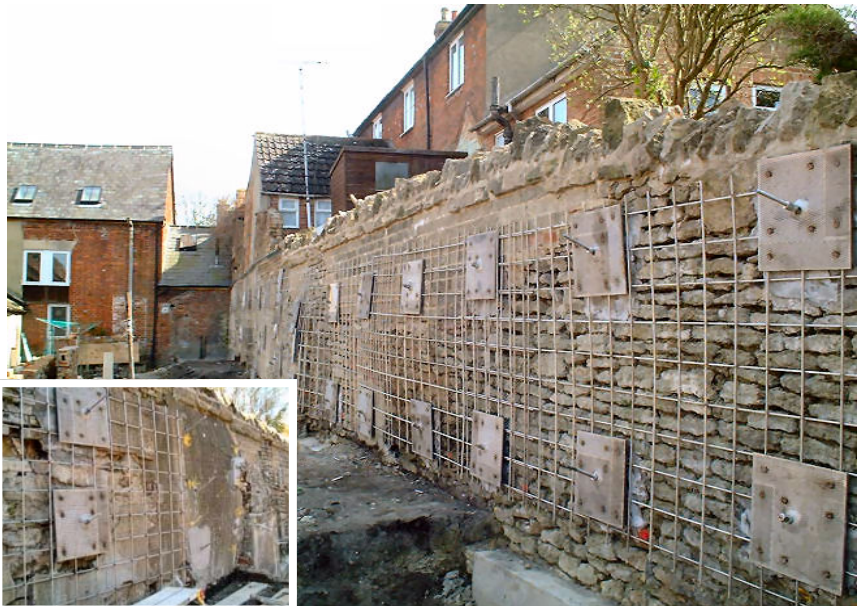
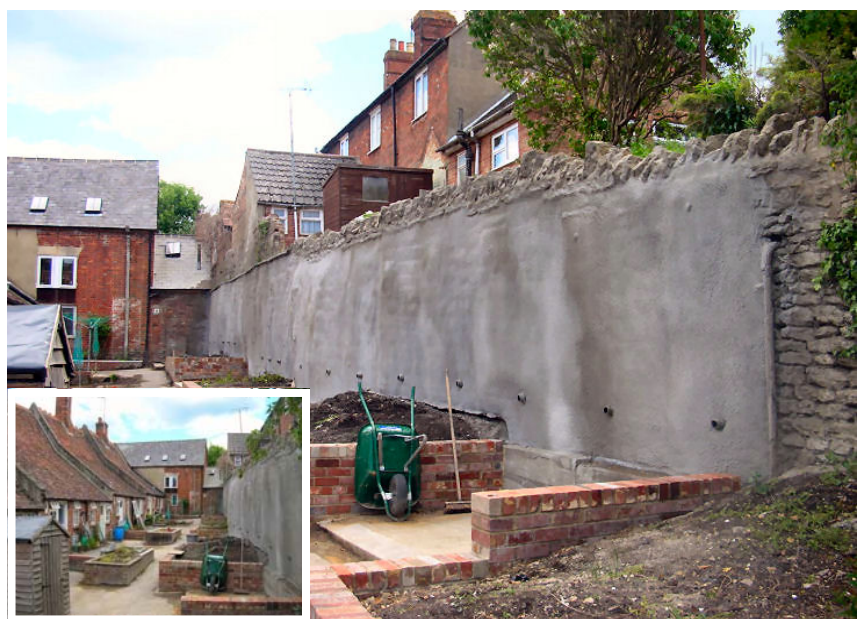
Structural Engineers identified that the rear retaining wall was at risk of collapse saying the wall "could fail without further warning signs", causing injury to residents and properties.

With the problem also affecting five dwelling houses behind the retaining wall, action had to be taken to stabilise the retaining wall. All eight almshouses are occupied and would be throughout the period of proposed remedial works.

Protectahome installed forty Cintec ground anchors to a depth of six metres using specialist equipment. The anchor body was based on an M20 stud. A stainless steel weld mesh was then fixed in place using a stainless steel pattress plate.

To prevent a build up of free ground water behind the retaining wall, a series of weep holes were created in the base of the wall.

The newly stabilised wall was finished with a spray applied concrete coating.
